Test Report

Report No. **MTS-21315-1 METF**
Issue Date 15/07/2015
Test Date 9/07/2015

MTS Metallurgical Testing Services was engaged to perform load tests on a frameless glass balustrade to the requirements of AS/NZS 1170.1 - 2002.

Test Item(s) One (1) only Frameless Glass Balustrade with 38mm Round Slotted Tube Handrail supported on Square and Round Core Drilled "Bolt-through" and Square and Round Deck Mounted "Bolt-through" spigots.

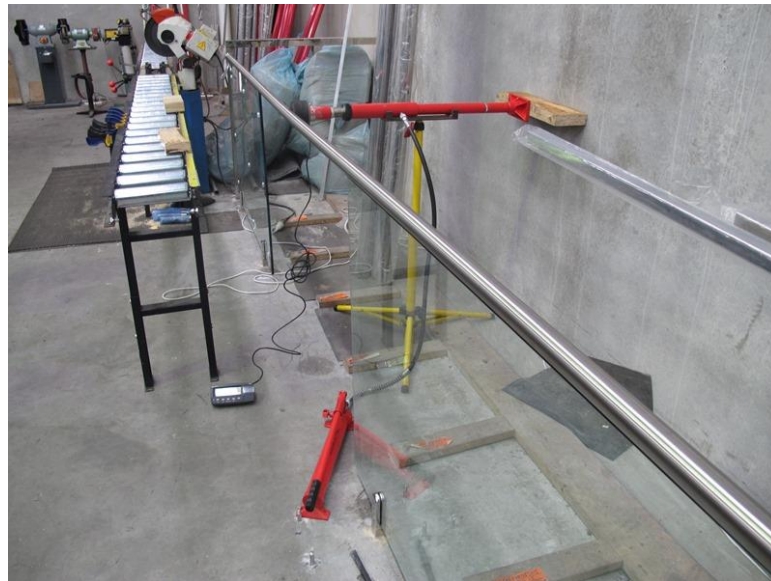
Specimen ID	Test Load (N)	Permanent Distortion (mm)	Observations	Assessment
Top Rail Outwards Test	600	1.0	No signs of damage or loosening.	COMPLIES

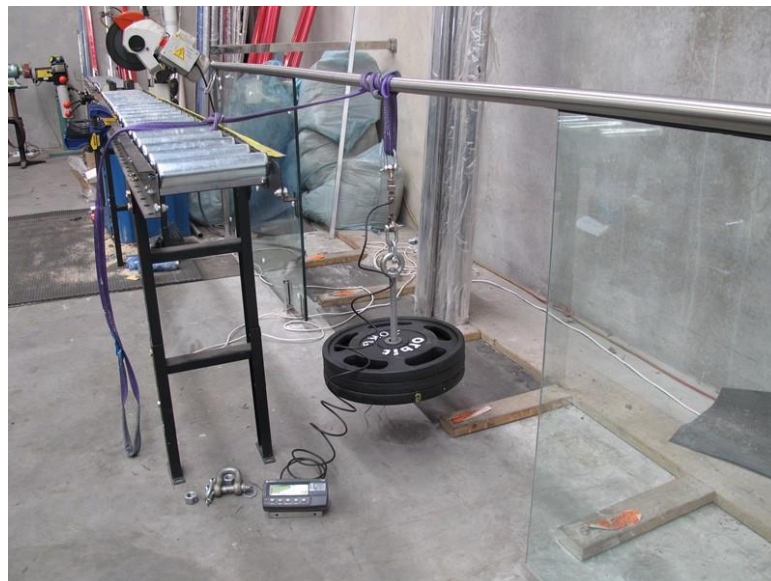
Top Rail Downwards Test

38mm Round tube under the test
 No signs of damage or loosening.

COMPLIES

38mm Round tube under the test
