# Test Report

<b>To</b>	GR8 Glass Pool Fencing 15/51 Lancaster Rd, Wangara WA 6065	<b>Report No.</b>	<b>MTS-21316-1 METF</b>
<b>Order No.</b>	PAUL 4	<b>Issue Date</b>	15/07/2015
		<b>Test Date</b>	9/07/2015

**Test Item(s)** One (1) only Frameless glass pool fence panel on Core Drilled "Bolt-through" spigots.

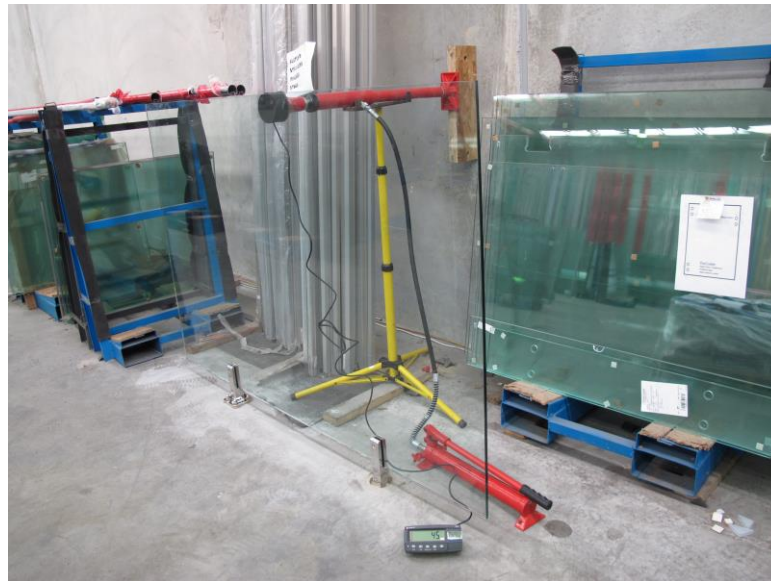
Specimen ID	Test Load (N)	Deflection Under Load (mm)	Permanent Distortion (mm)	Observations	Assessment
21316	330	30.0	4.0	No signs of fracture, loosening or distortion beyond the specified requirements.	COMPLIES

Square Core Drilled spigots under the test.
